Reenergy-Dovetail Odor Complaint Documentation

Date and Time of Complaint Investigation:	9/8/2021 19:00 – 19:30
Inspector Name:	Glen Vonderembse
Wind Direction and Speed:	North of West to West 3-7 mph
Temperature and other Weather Obs.:	~74 F Partly Cloudy

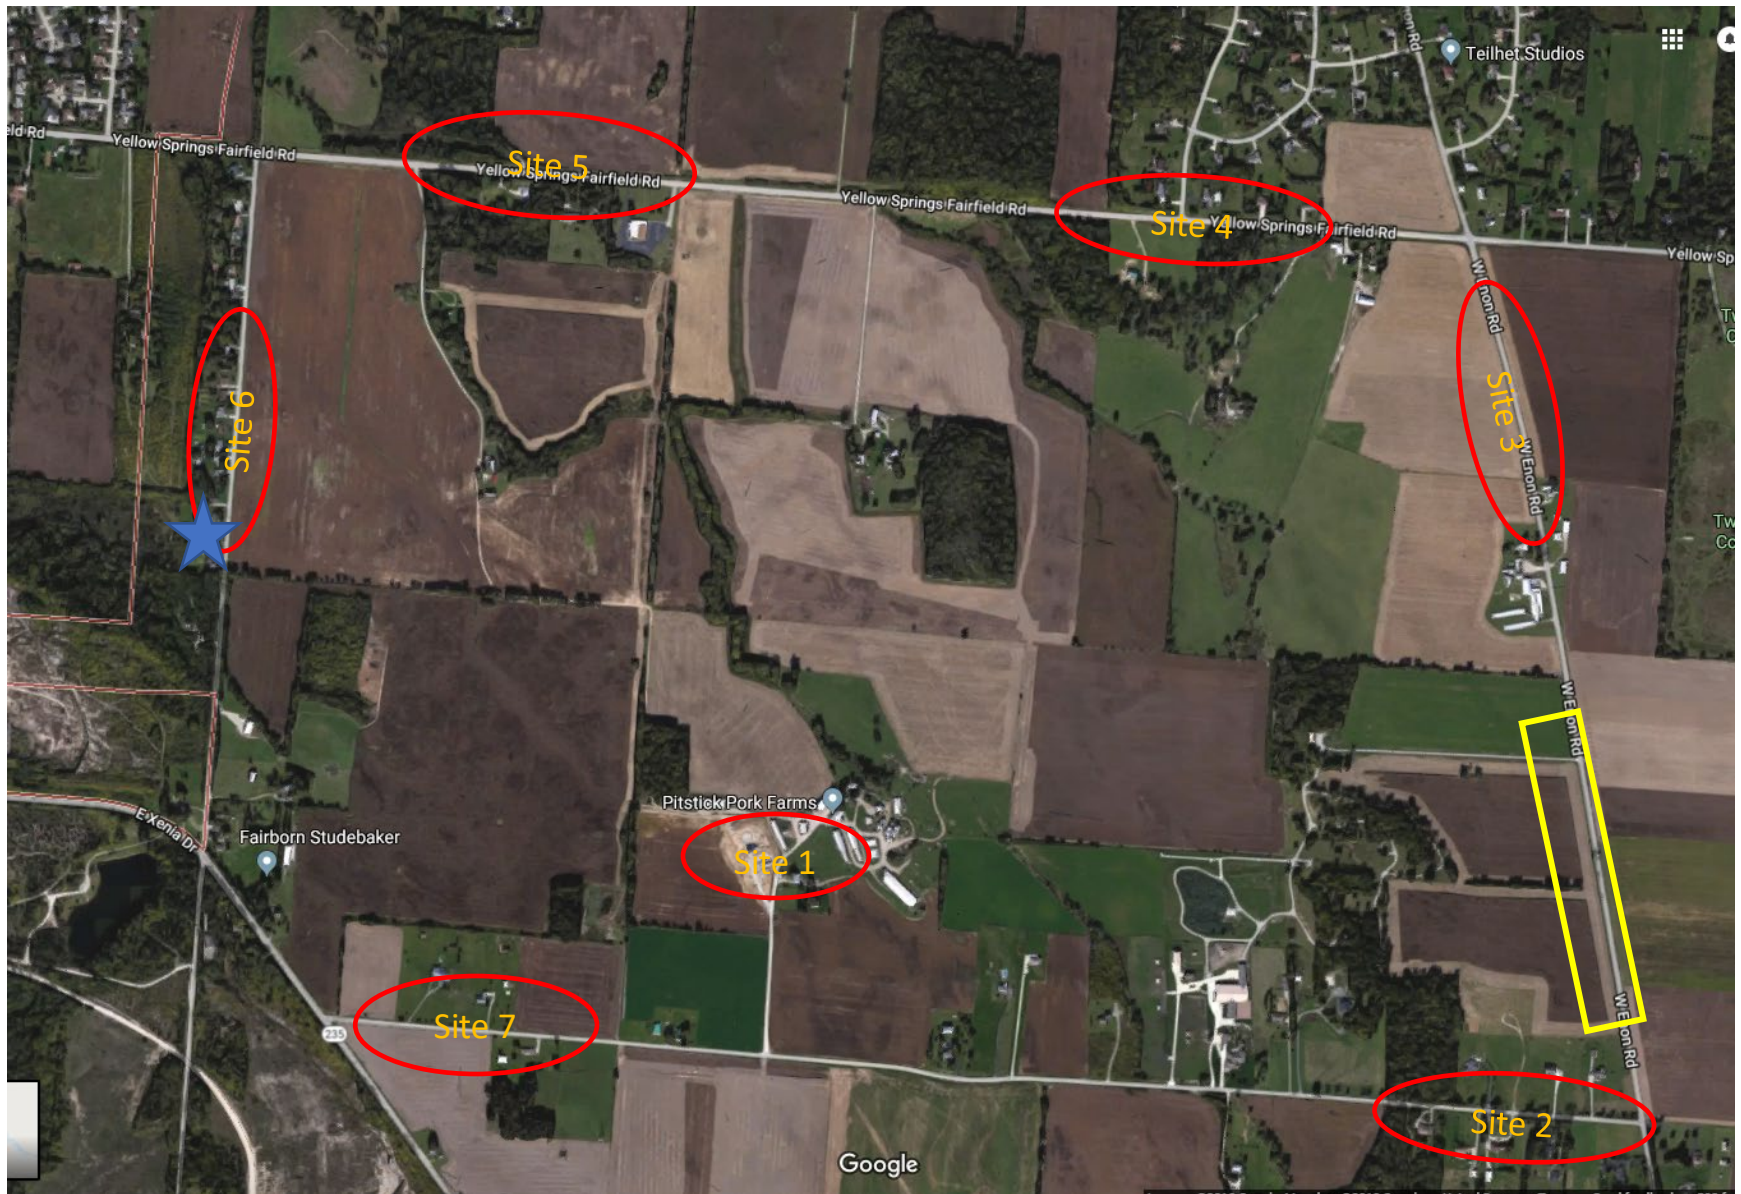
- Lay flat type hose setup to discharge into storage tank. Hose observed heading due west from tank towards adjacent private field. Other end of hose was non-observable.
- (2) tow behind sludge tree/mixer implements present in roadway, east of storage tank.
- Generator/flare non-operational.
- Digestate in storage tank observed to be bubbling.
- Storage tank ammonia odor was very strong.
- Site #2 odor was cut hay. Evidence of recent cutting of hay on southeast corner of Herr/Enon intersection.
- Blue star on map is location of recent ground disturbance of a residence appearing to be related to work on a septic soil absorption system.
- Yellow box on map is area of detected odor: Character – Horse Manure – Hog Manure; Intensity – mild
